## New Building Inspection Report - Completion Stage

New Building Inspection Report - Completion Stage

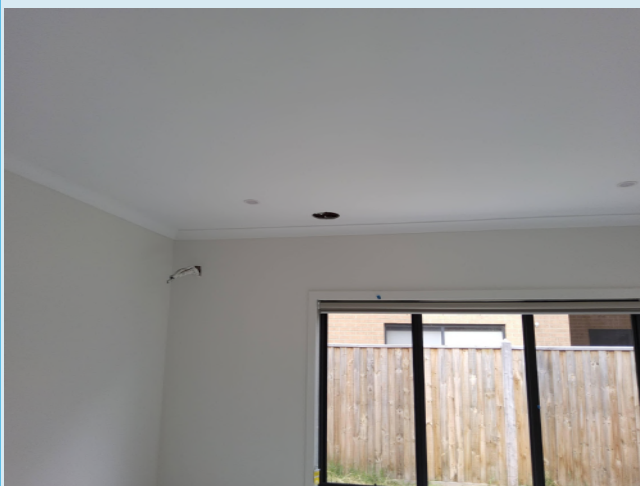
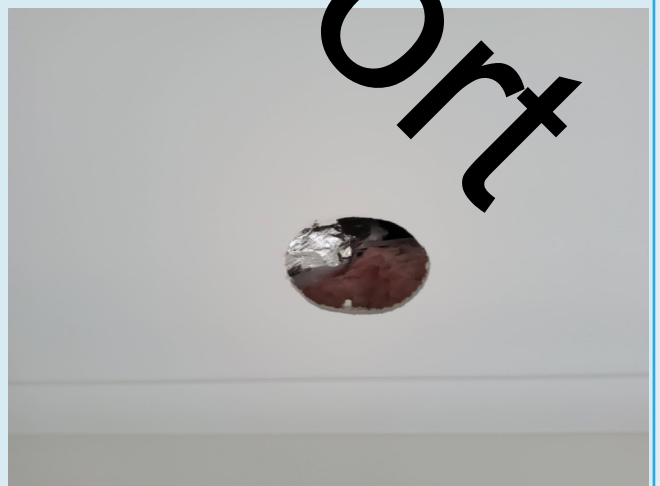
Family, rear elevation left-hand side, it has been observed that the heating duct has not yet been fitted off.

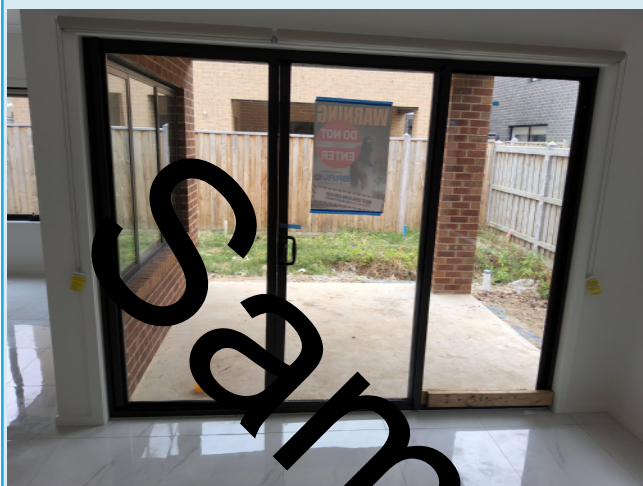
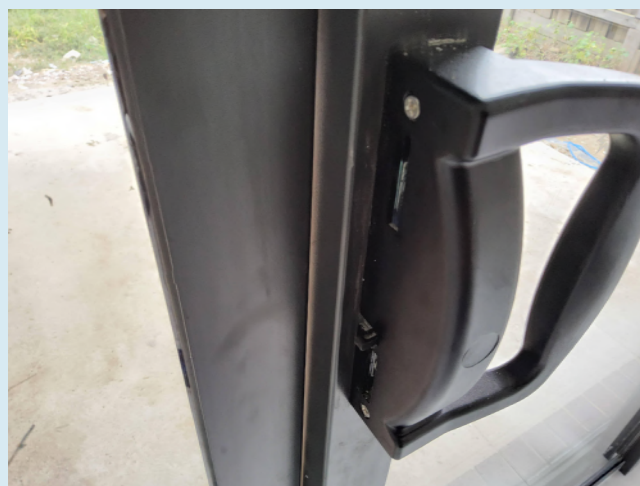
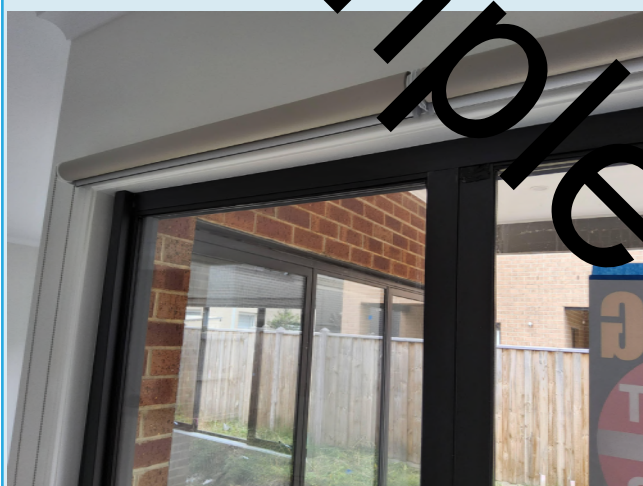
Dining, sliding door, it has been observed that the lock mechanism appears not to be installed, also the left-hand side fixed panel appears to be misaligned.

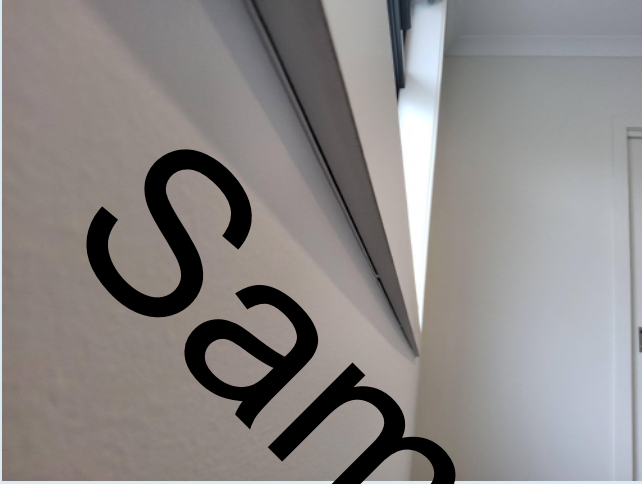
Hallways and general living spaces	
Minor and/or Major Defect	Walls
<b>Comments</b>	
Check throughout, it has been observed that there appear to be gaps to the top and bottom of the doors and windows, the associated gaps may effect the six star energy rating and cause loss of amenity if not sealed adequately.

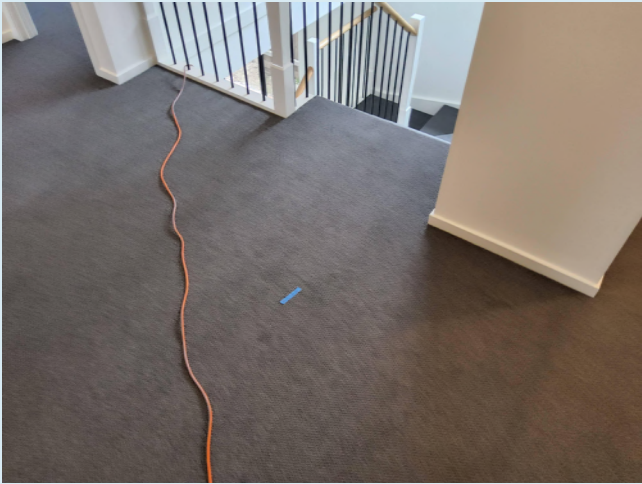
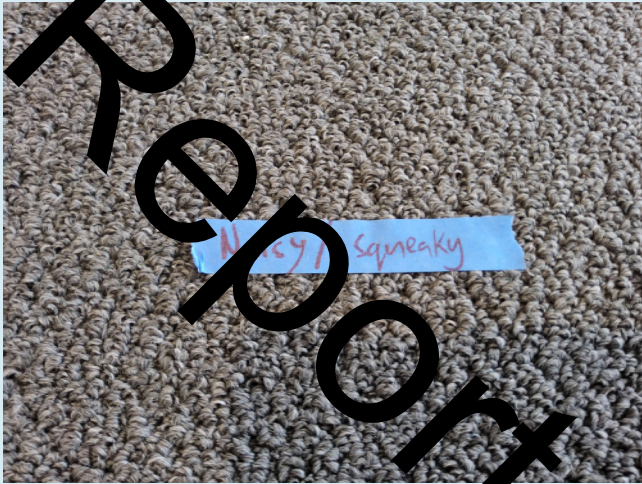
Hallways and general living spaces	
Minor and/or Major Defect	Floor
<b>Comments</b>	
First floor, adjacent to the staircase area, it has been observed that the floor appears to be noisy/squeaky underfoot.

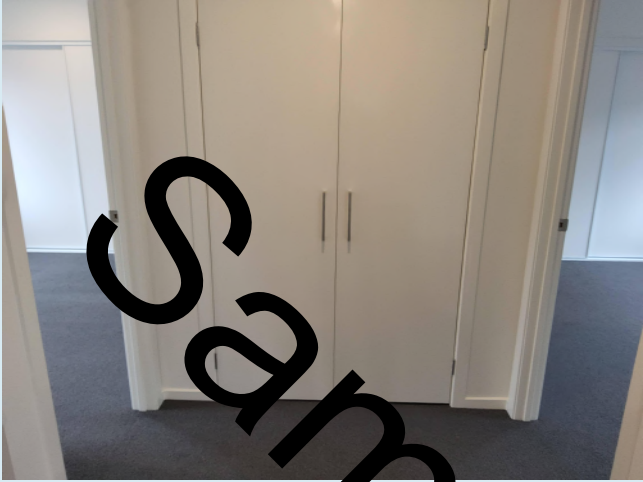
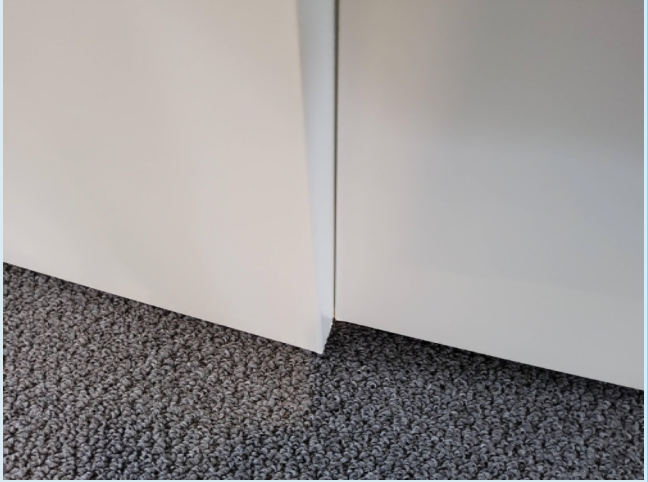
Hallways and general living spaces	
Minor and/or Major Defect	Doors
<b>Comments</b>	
First floor linen, it has been observed that the bottom section, centre area of the doors appear to be binding.

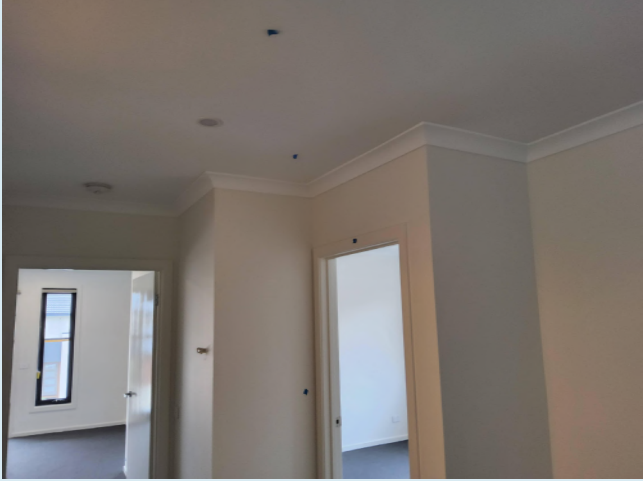
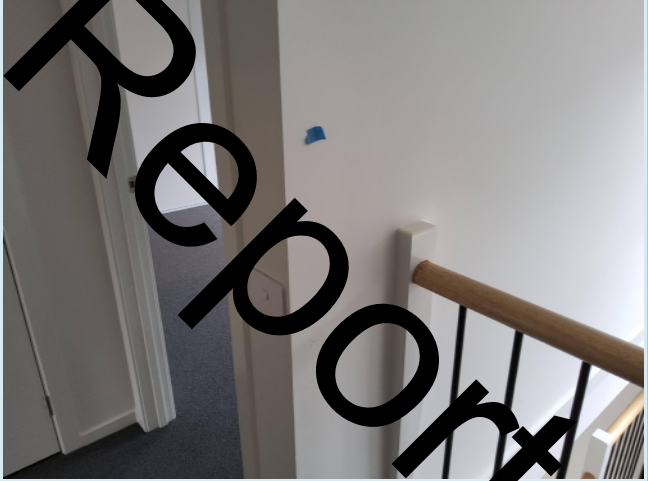
Hallways and general living spaces	
Minor and/or Major Defect	Walls
<b>Comments</b>	
General note, paint touch-ups required throughout

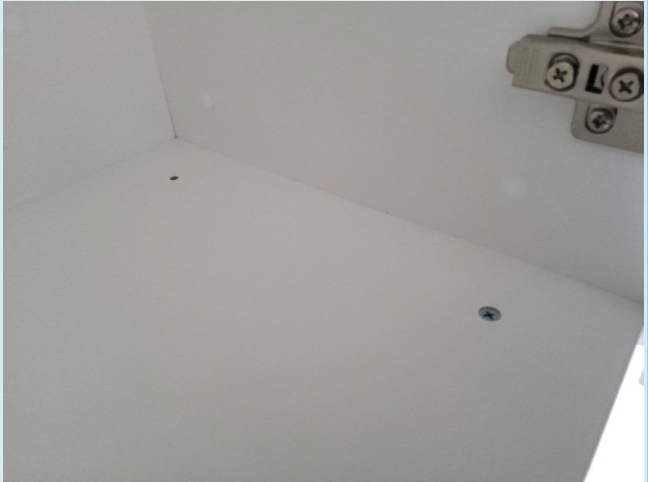
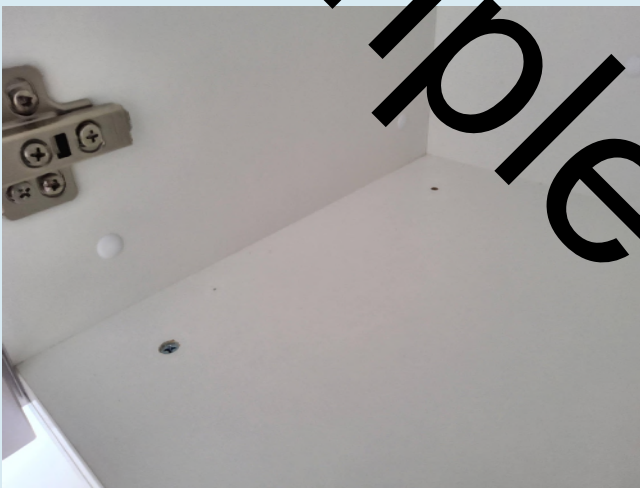
<b>Kitchen</b>	
<b>Minor and/or Major Defect</b>	<b>Cabinets / Drawers</b>
<b>Comments</b>	
<p>Left elevation, it has been observed that there appear to be screw cap covers missing to the overhead cabinets, either side of the rangehood.</p>

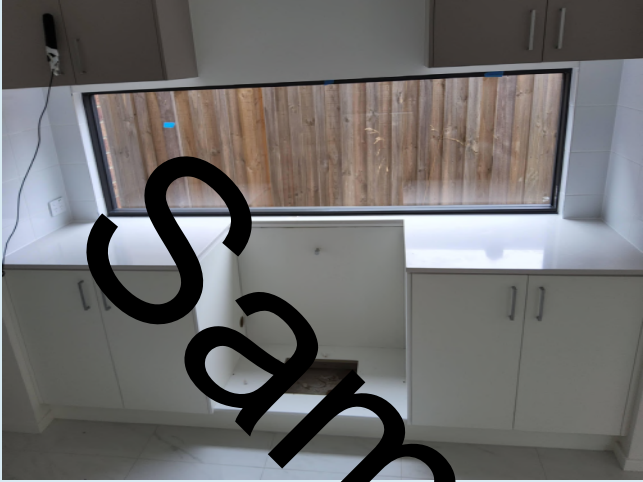
<b>Kitchen</b>	
<b>Incomplete Item</b>	<b>Appliances ( Oven, Range Hood, Dishwasher)</b>
<b>Comments</b>	
It has been observed that the appliances were not yet installed at the time of the inspection.

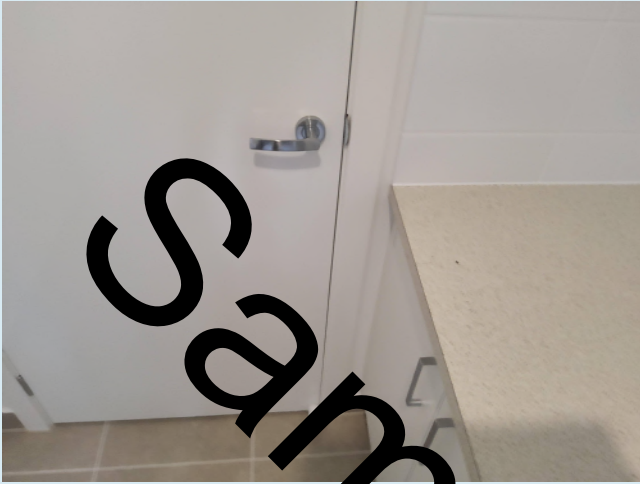
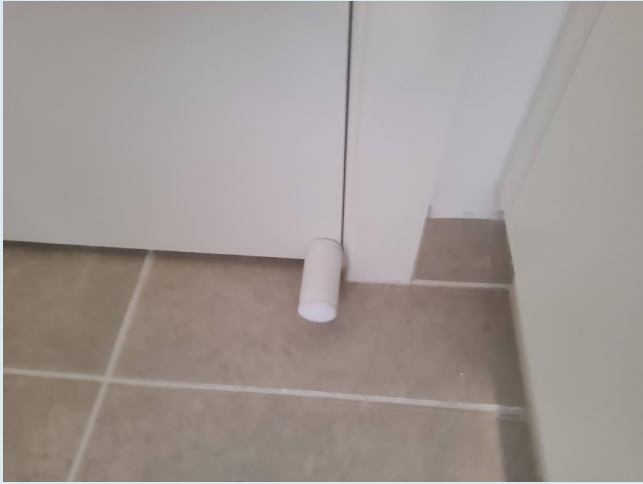
<b>Laundry</b>	
<b>Minor and/or Major Defect</b>	<b>Doors</b>
<b>Comments</b>	
It has been observed that the door margins appear to be tight to the bottom right-hand side of the door.

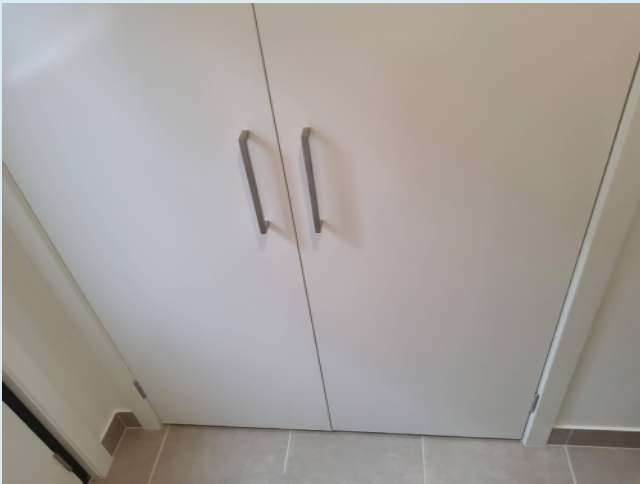
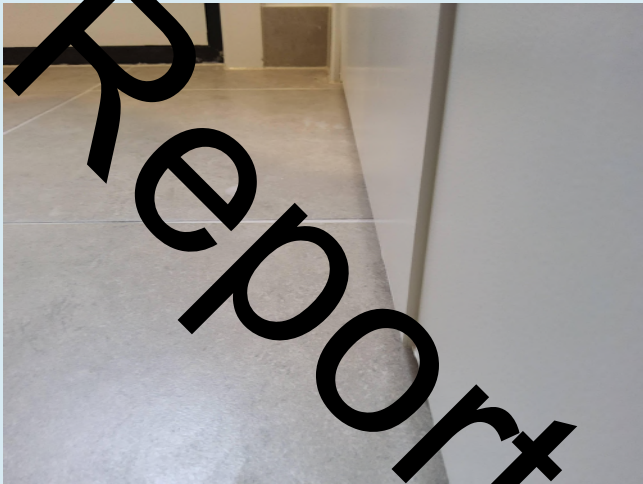
<b>Laundry</b>	
<b>Minor and/or Major Defect</b>	<b>Doors</b>
<b>Comments</b>	
It has been observed that the center face of the doors appear not to sit flush.

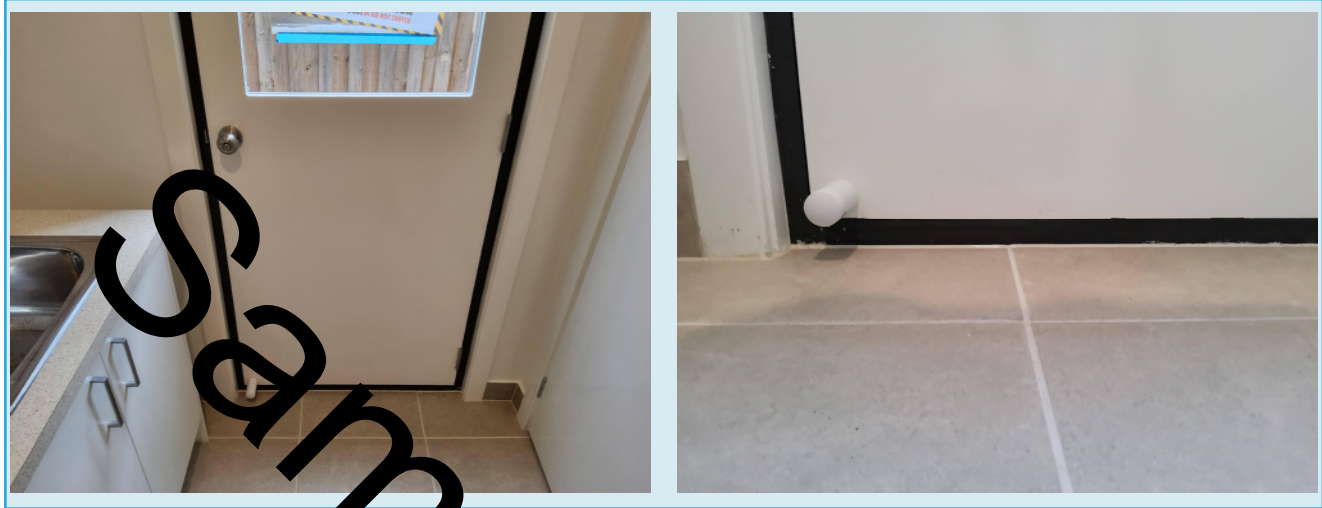
Rear access door, it has been observed that the bottom of the door appears to be binding on the door sill.

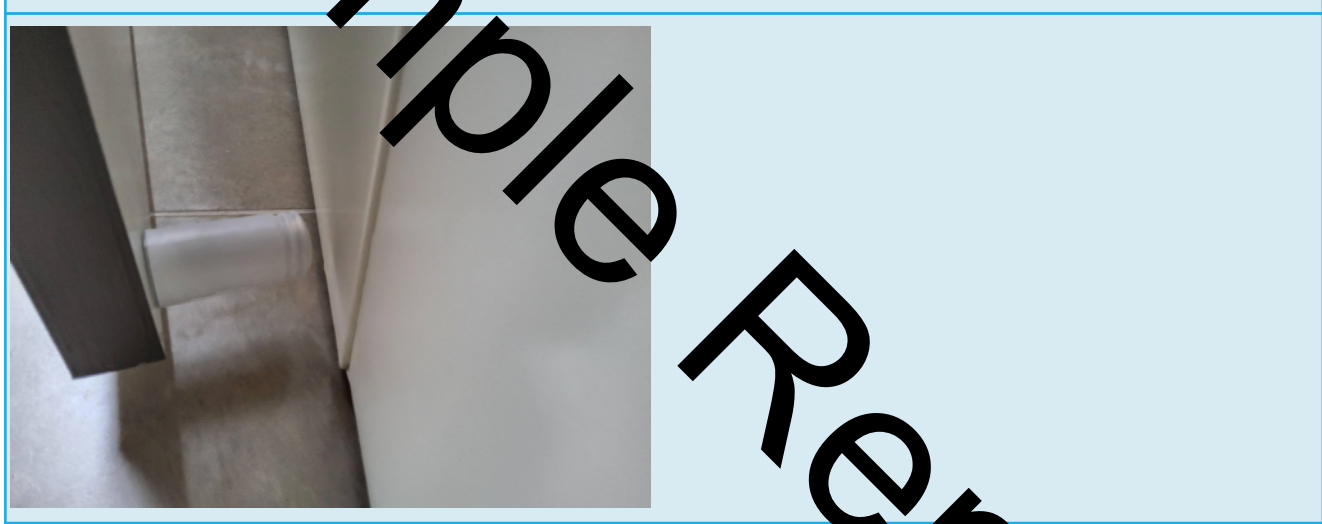
It has been observed that the door stop for the rear access door appears to be short, the door handle is making contact with the broom cupboard door handle prior to the door stop making contact with the door.

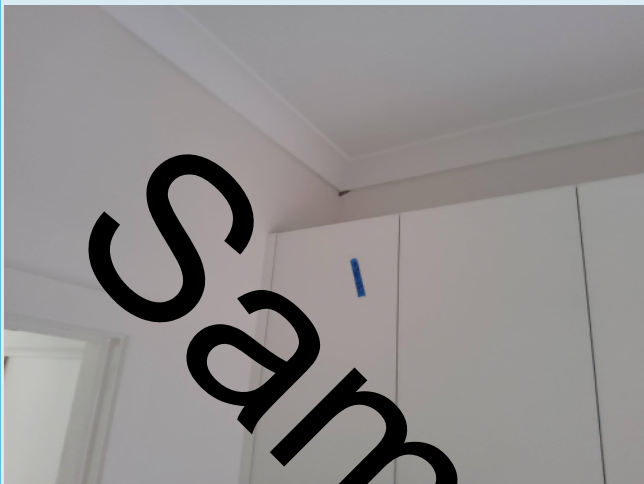
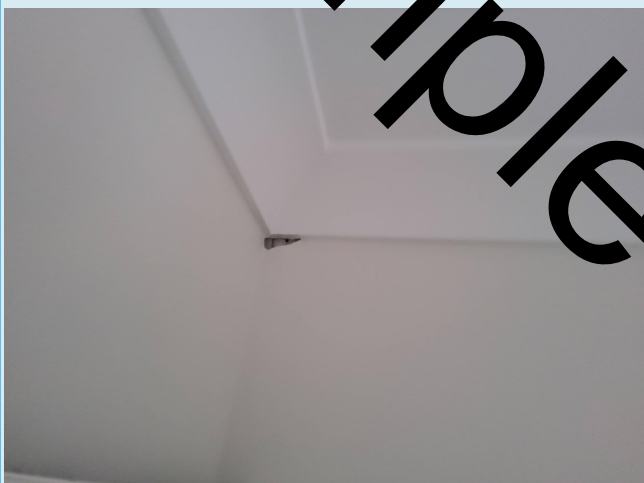
Laundry	
Minor and/or Major Defect	Walls
<b>Comments</b>	
Front elevation top left hand corner, it has been observed that there appears to be a hole to the plasterboard below the cornice, patch and paint required.

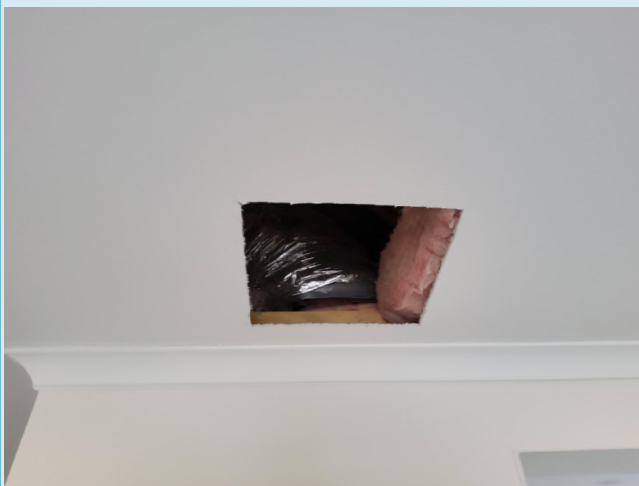
It has been observed that the cooling duct was not yet fitted off at the time of the inspection.

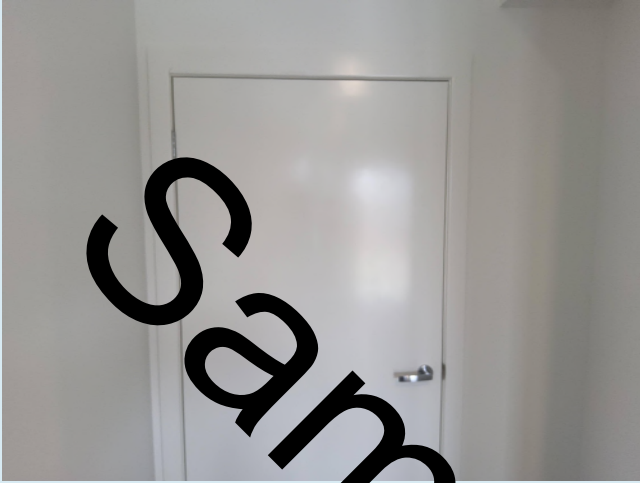
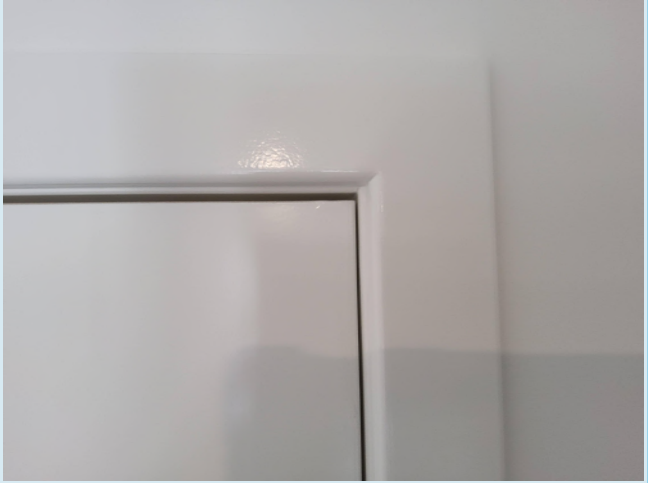
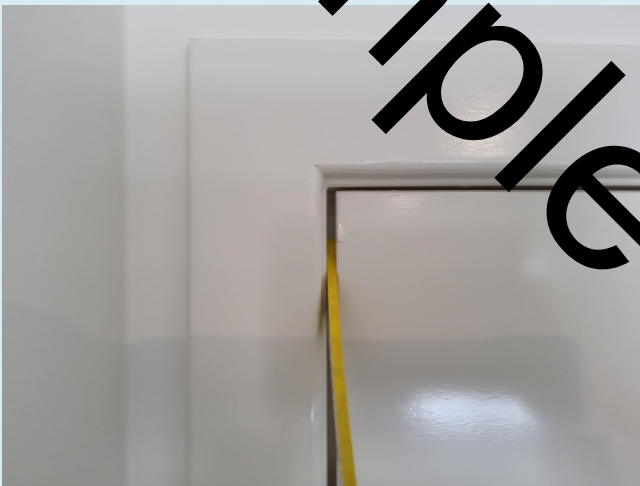
<b>Bedroom 1</b>	
<b>Minor and/or Major Defect</b>	<b>Doors</b>
<b>Comments</b>	
It has been observed that the door margins appear to be less than 2mm and exceed 5mm.

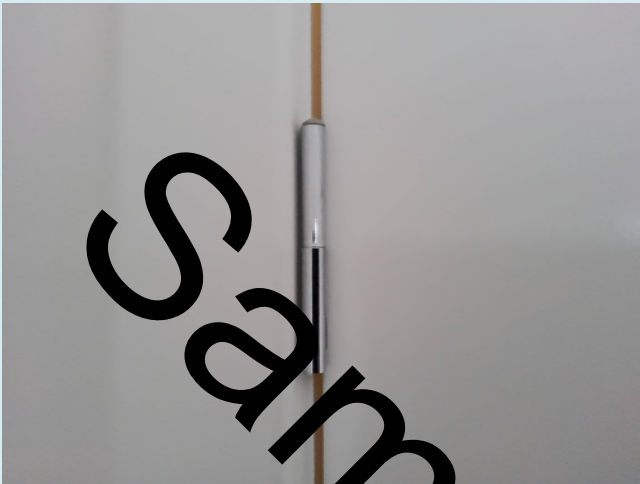
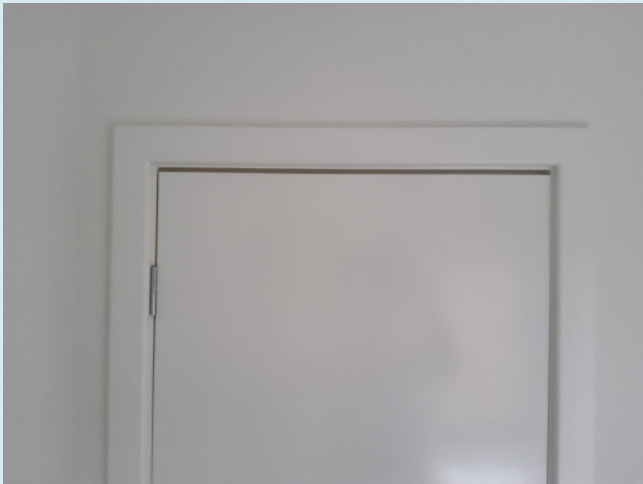
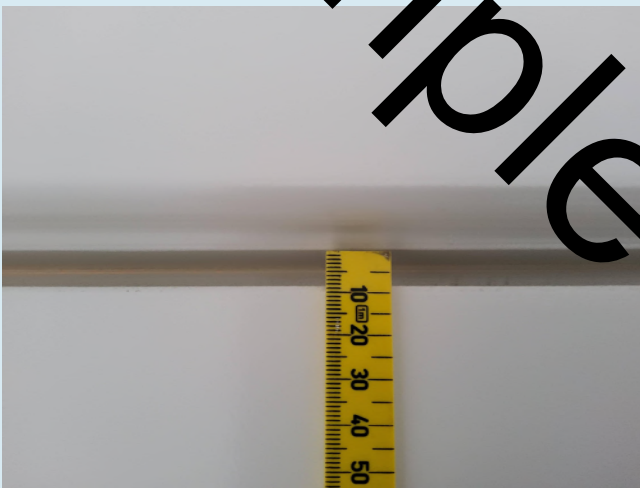
<b>Bathroom 1</b>	
<b>Minor and/or Major Defect</b>	<b>Doors</b>
<b>Comments</b>	
It has been observed that there appears to be insufficient gap for the lift off hinges to function as intended, the minimum allowable gap for lift off hinges is 10mm, this minimum gap has not been achieved in this case.

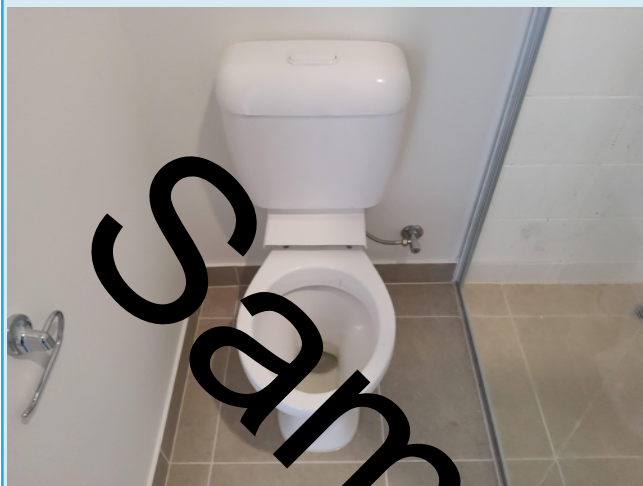
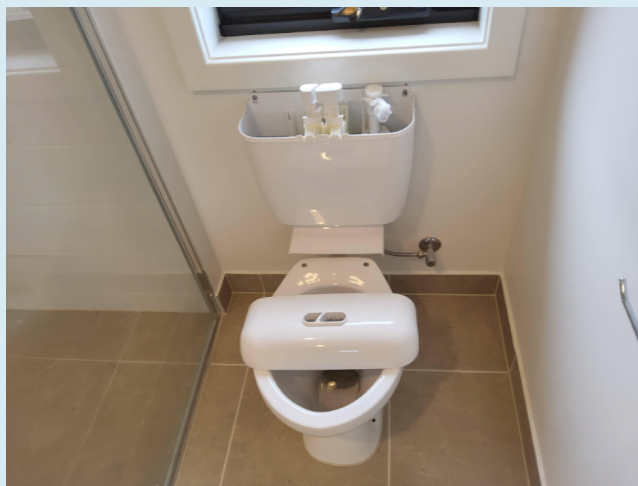
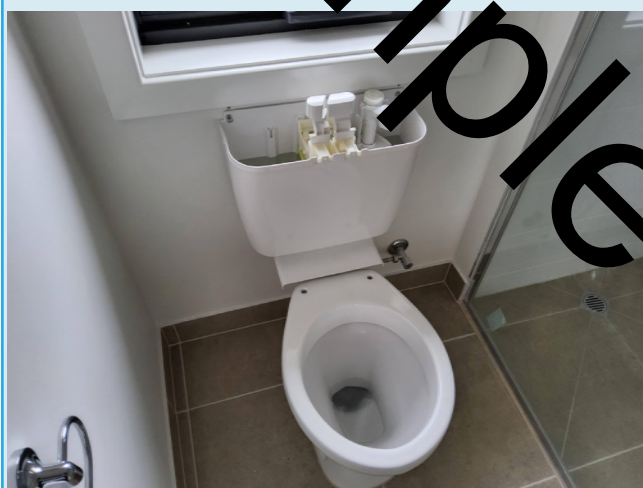
General note, check throughout, it has been observed that the toilet seats and covers for the toilet cisterns were not yet been fitted off at the time of the inspection.

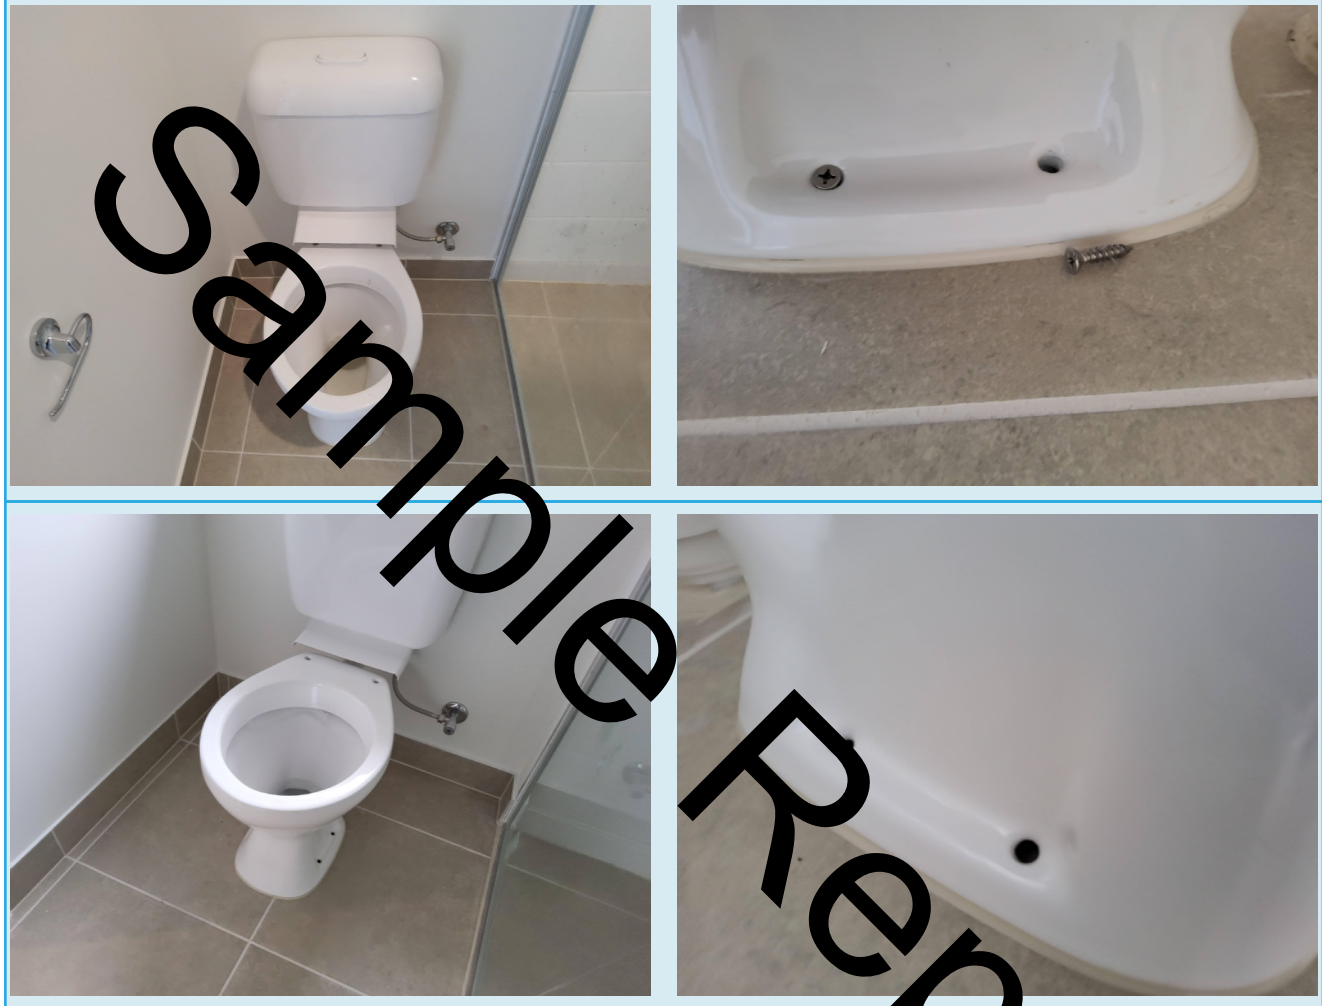
General note, check throughout, It has been observed that the toilet pans have not been anchored to the slab/flooring as per the manufacturers installation guide, the toilet pans are only being held in place with silicone, the manufacturers installation guide specifies that the toilet pans be anchored to the slab/flooring using to provided anchor screws, this has not been achieved.

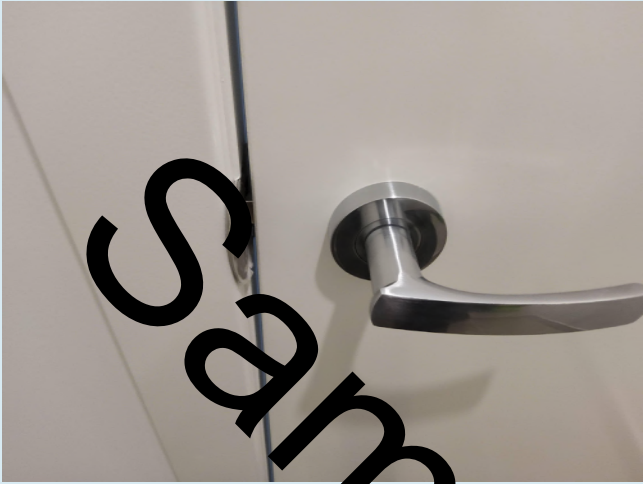
Ensuite 1	
Minor and/or Major Defect	Doors
<b>Comments</b>	
Ensuite WC, it has been observed that the latch appears not to engage with the striker plate.

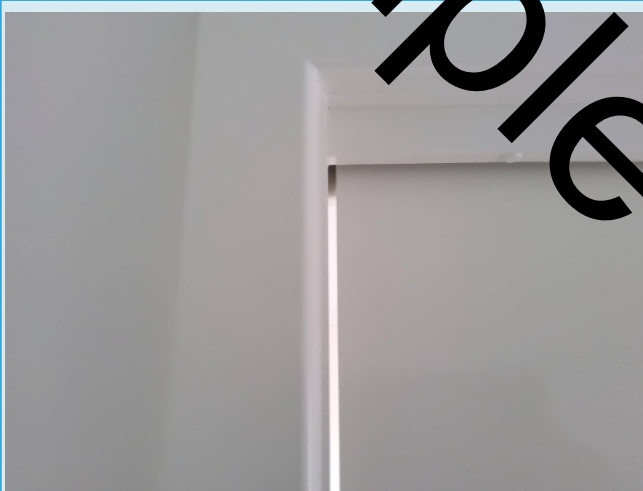
It has been observed that the cavity sliding door appears not to operate smoothly, also the top of the door edge appears not to sit flush with the door jamb.

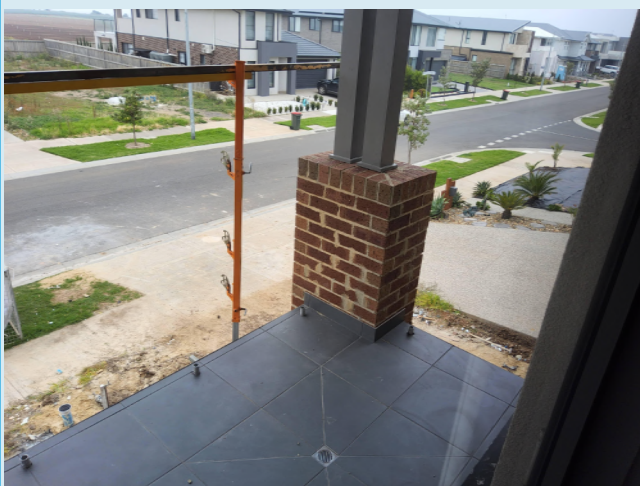
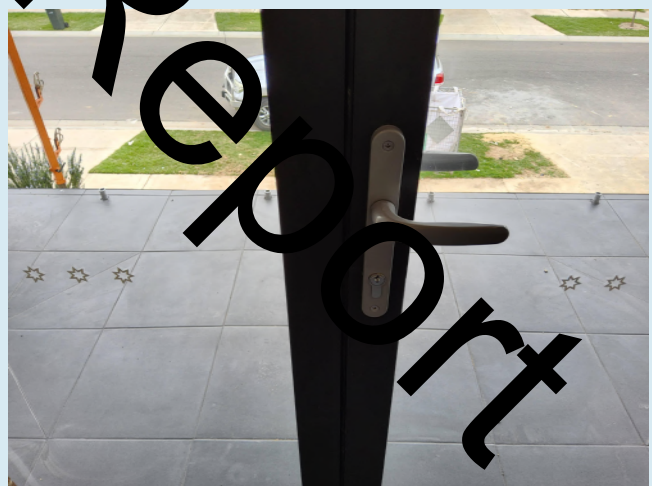
It has been observed that the balcony handrail was not yet installed. At the top of the inspection, the door from bedroom 1 leading to the balcony was locked at the time of the inspection, unable to inspect the balcony area due to the door being locked.

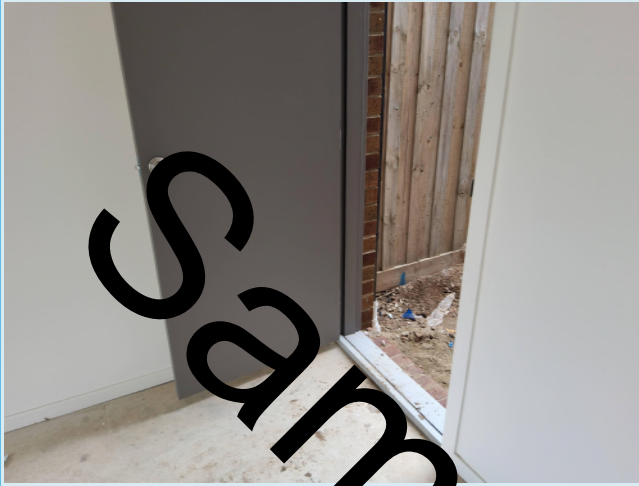
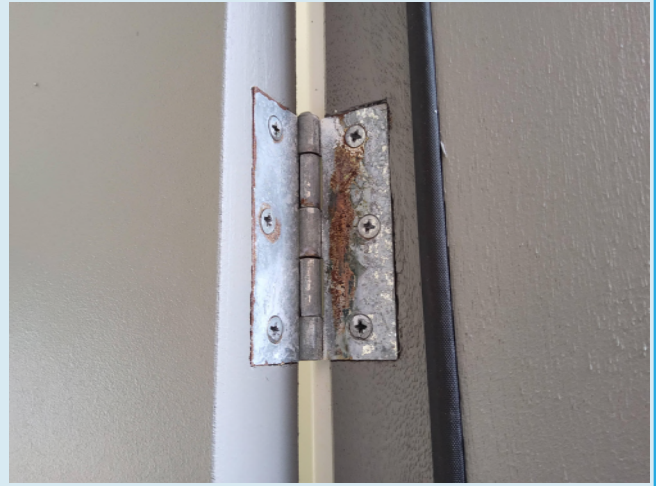
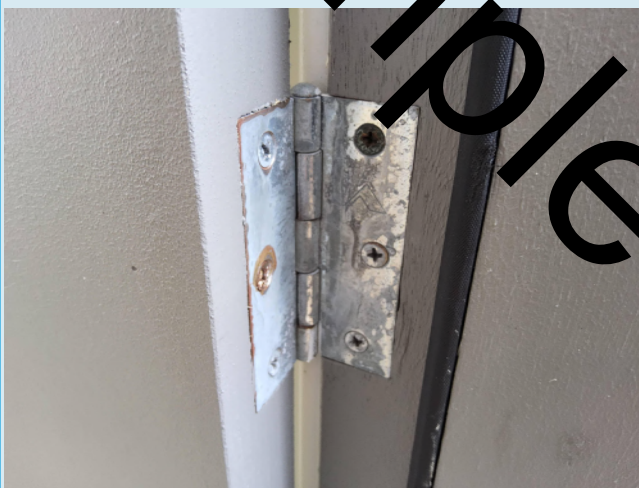
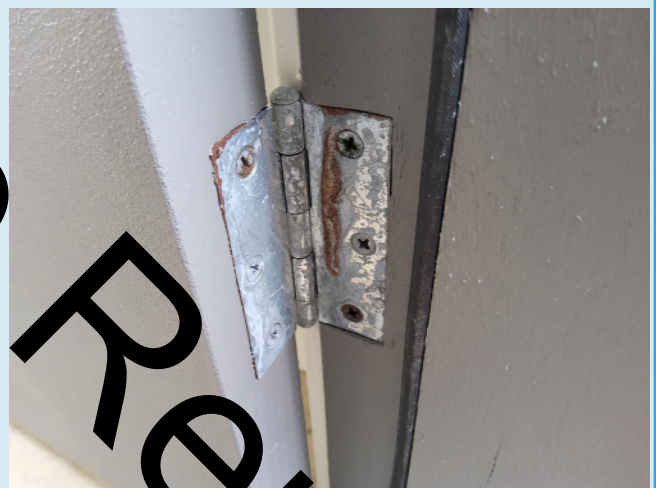
Garage, rear access door, it has been observed that the hinges appear to be rusty, all rusted door hardware will need to be replaced and present as new prior to handover.

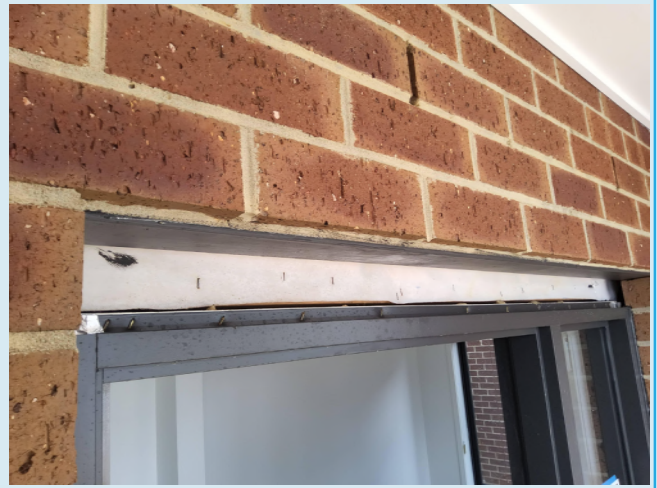
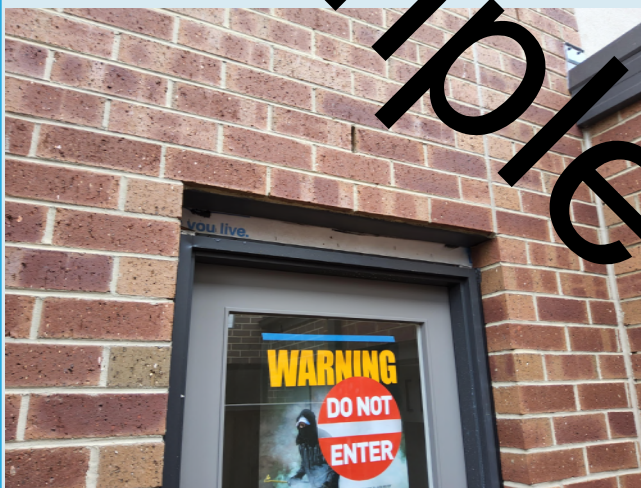
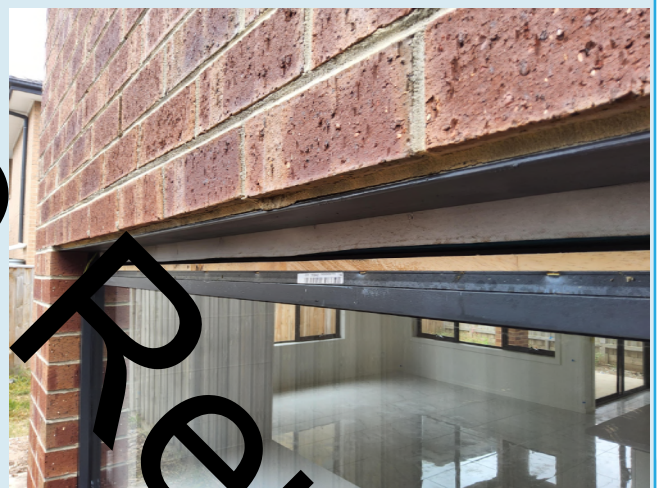
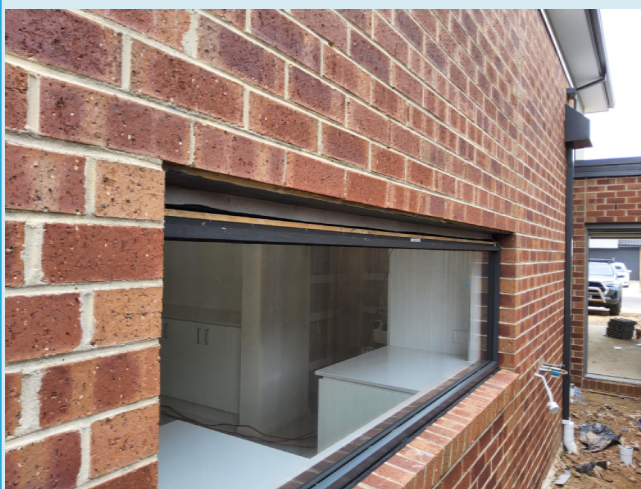
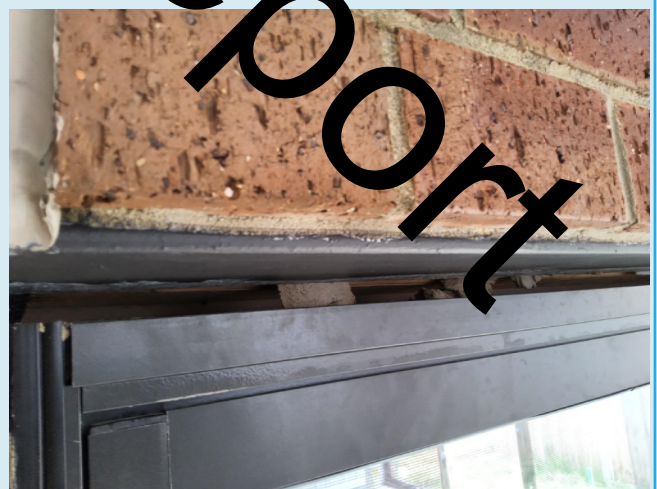
It has been observed that there appears to be a number of aluminium trims missing throughout to the top and side areas of the windows and door jambs.

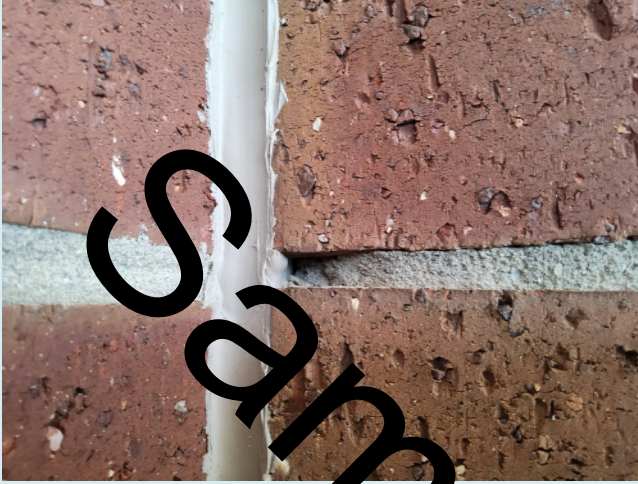
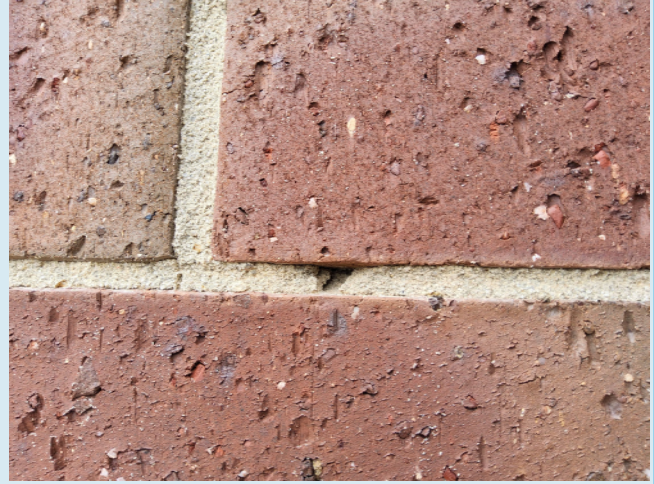
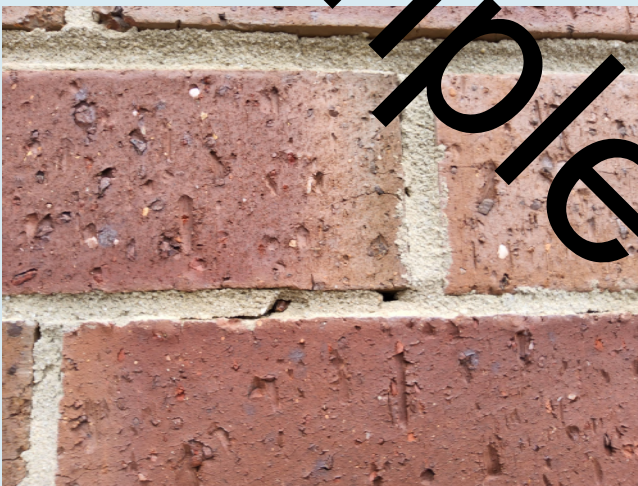
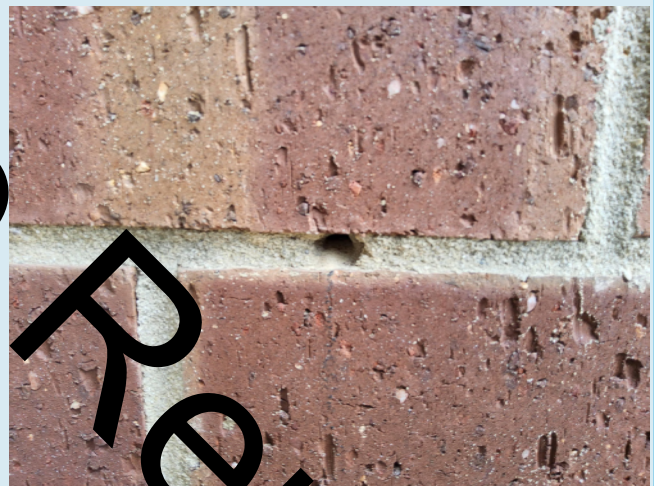
General note, check throughout, it has been observed that there appears to be gaps/holes to the brick mortar that will need to be filled in.

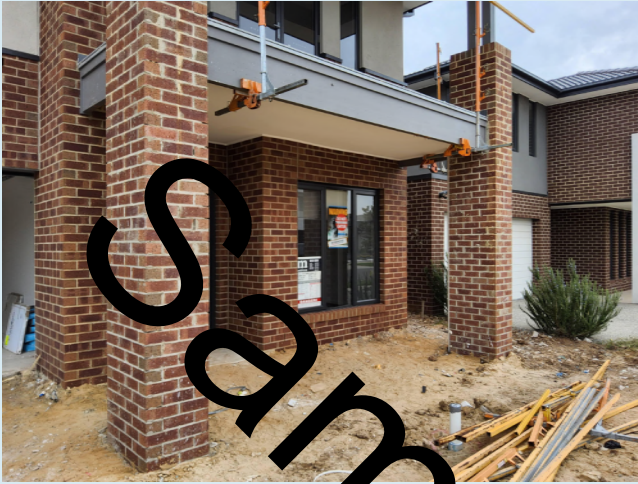
Front elevation it has been observed that the render was not yet completed at the time of the inspection.
