Warranty (Defect) inspection report

Type of Report: Warranty (Defect) Inspection

Warranty (Defect) Inspection report

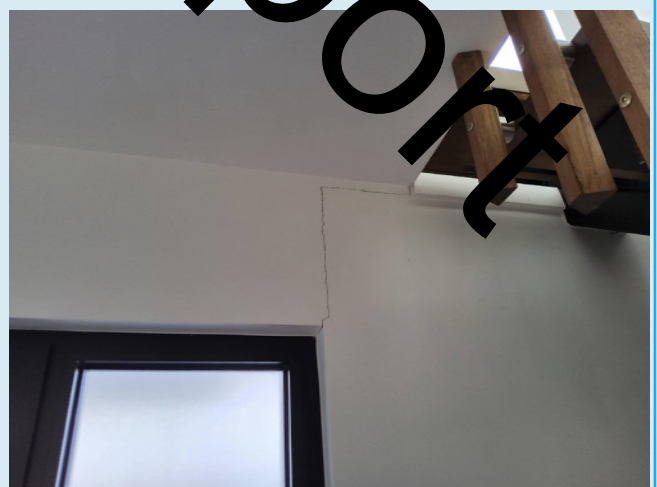
Crack above entry door. Crack is due to stress point and also footing movement. Builder to attend and rectify

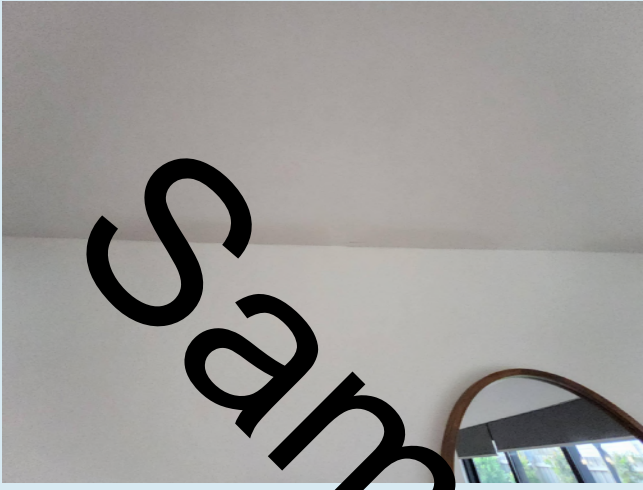
Hallways and general living spaces	
Minor and/or Major Defect	Ceilings
Comments	
Portion adjacent to garage is repaired. Sanding and painting is required

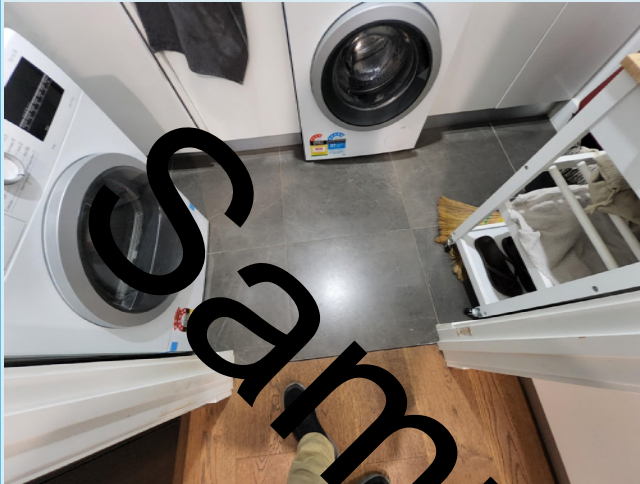
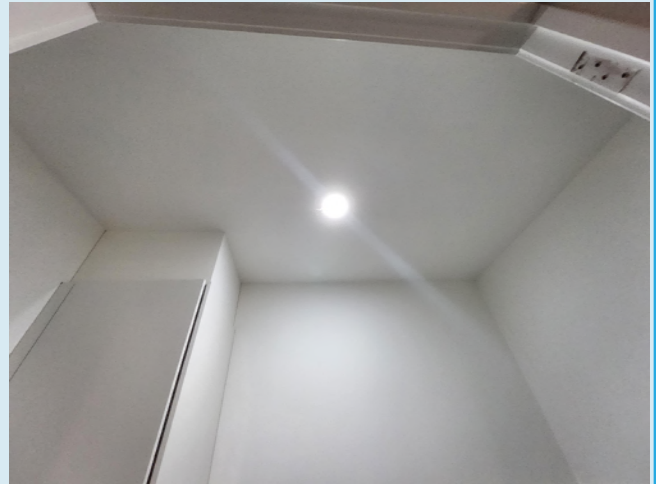
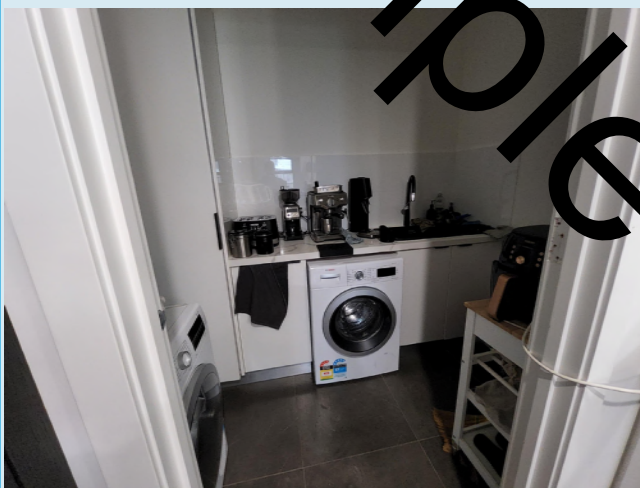
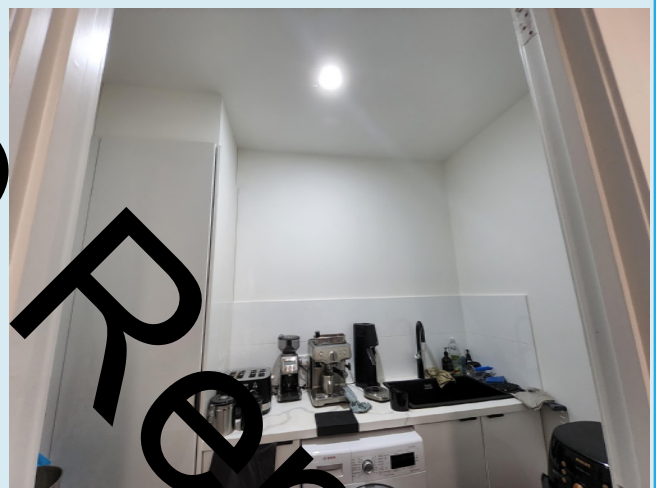
There is no exhaust fan installed within laundry area. I noted that there is no window and opening is to the kitchen and not external part of the building. It is mandatory to install exhaust fan and the pipes are to be directed externally and not within ceiling space.

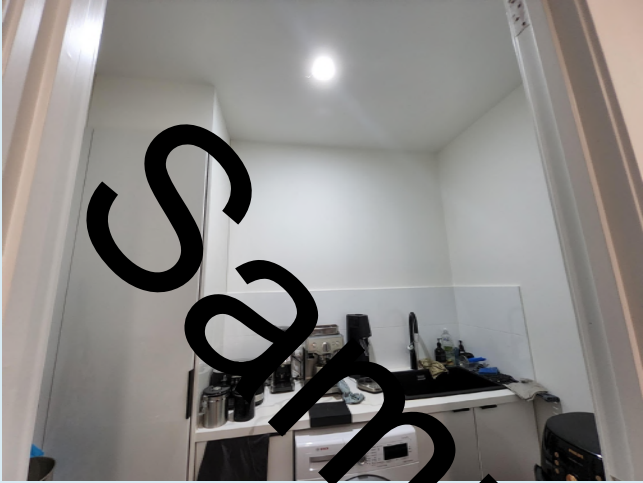
Laundry	
Incomplete Item	Ventilation
Comments	
<p>There is no exhaust fan installed within laundry area. I noted that there is no window and opening is to the kitchen and not external part of the building. It is mandatory to install exhaust fan and the pipes are to be directed externally and not within ceiling space</p>

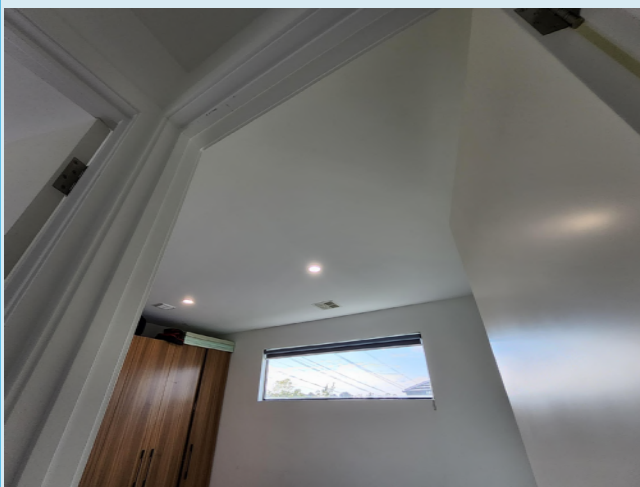
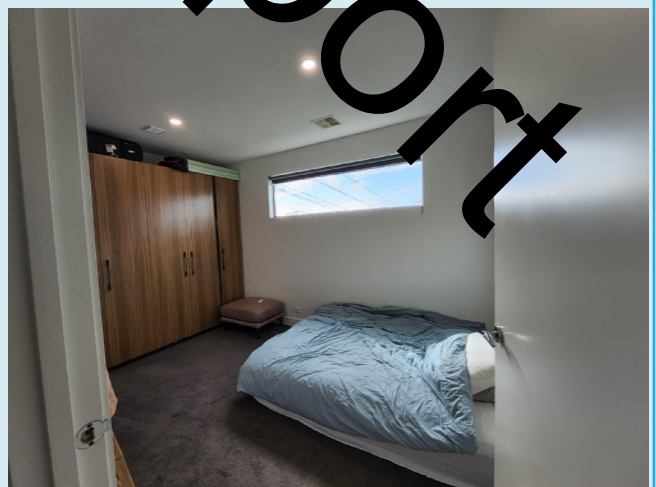
Window is a fixed window and not openable. Mechanical ventilation is not allowed in lieu of natural ventilation in domestic dwellings without an alternative solution prepared by suitably qualified person and approved by the building surveyor issued the building permit and occupancy permit. I recommend the window to be changed and an openable window to be installed.

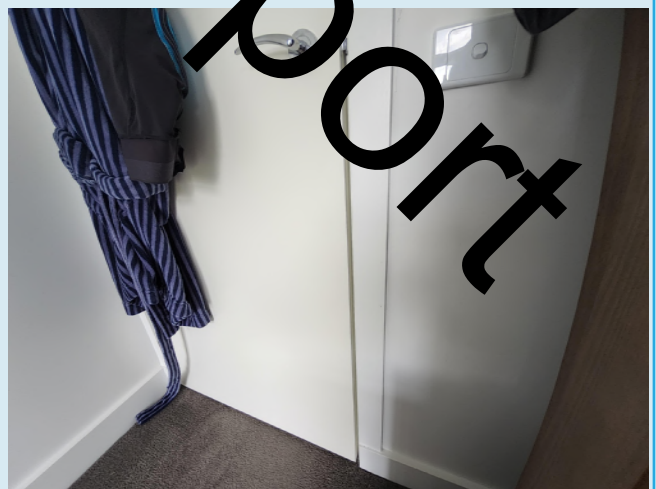
Door not closing properly. Builder to attend and rectify the issue

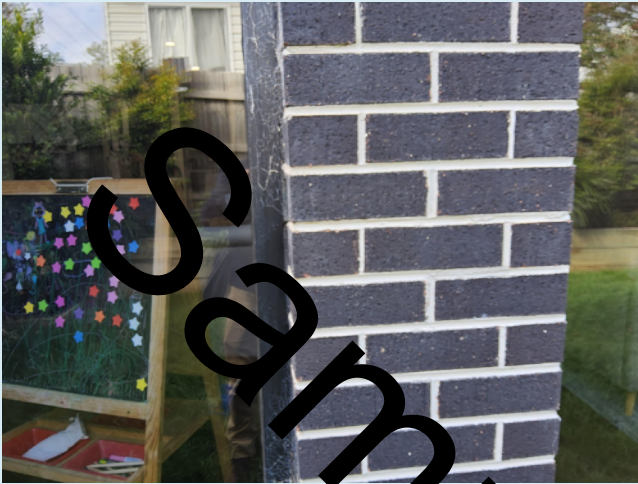
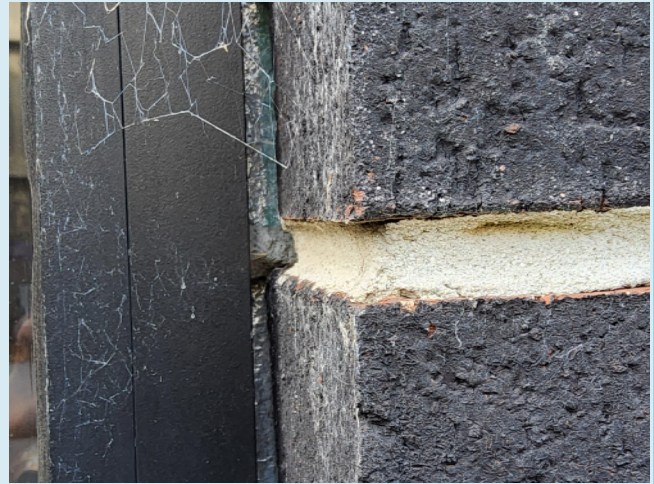
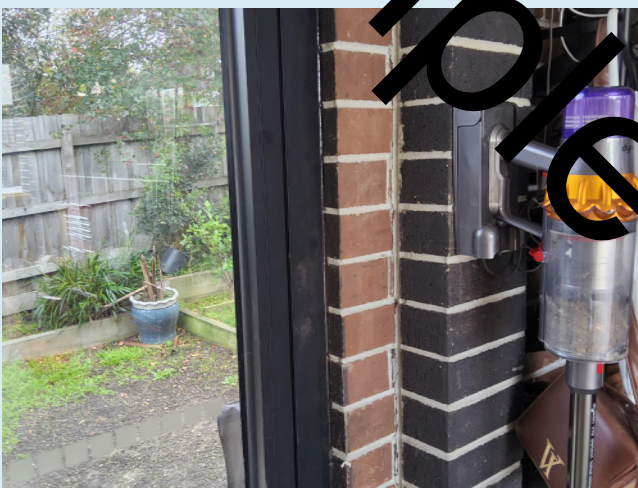
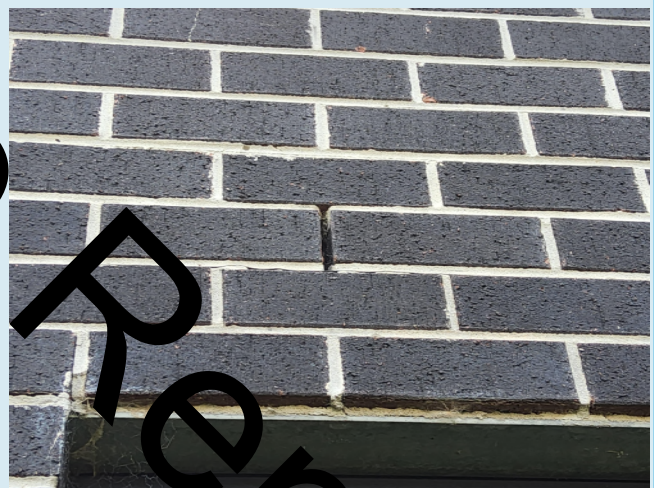
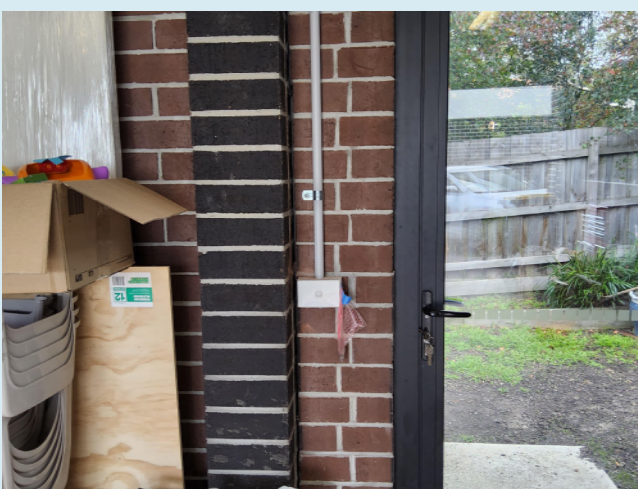
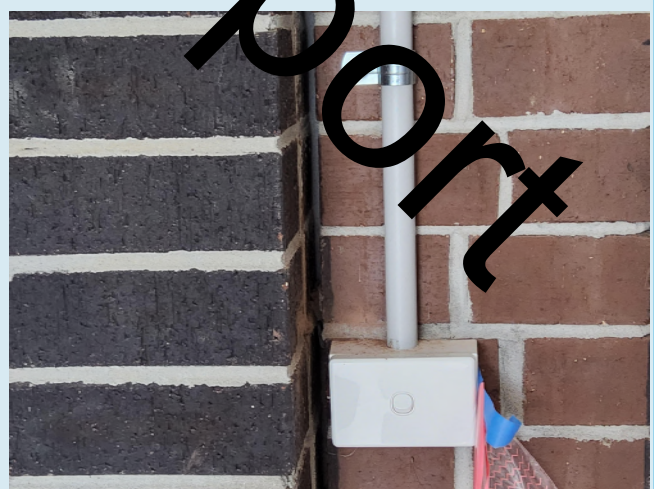
There are some cracks and movements joints on external walls. Crack above lintel is stress point due to loading over lintel. The gaps between windows and brick works and brick piers and wall in garage is due to footing settlement. Builder to consult with structural engineer for cause and rectification procedure.

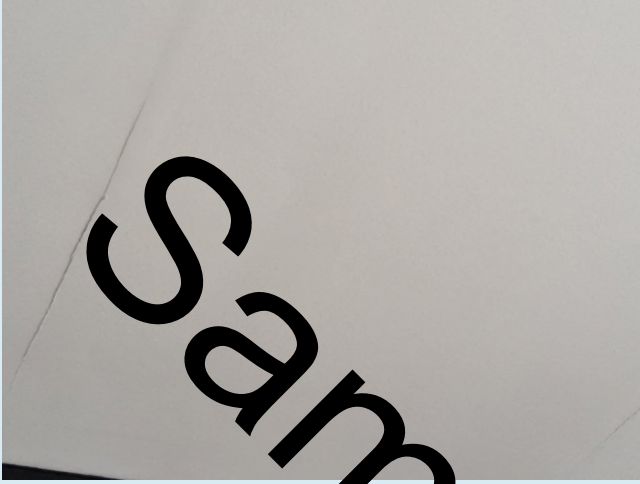
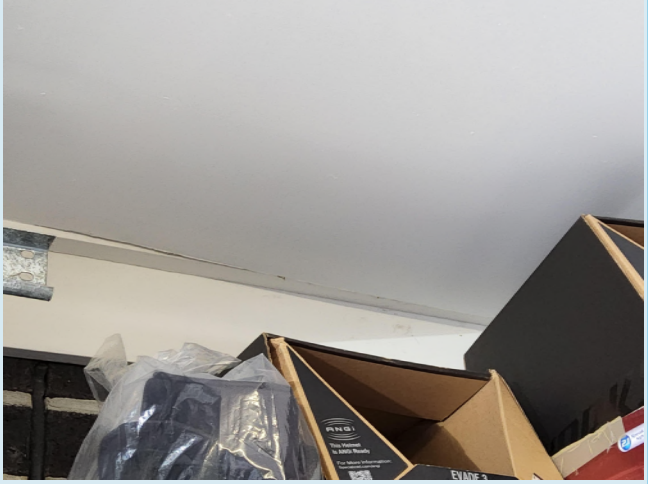
External > Exterior	
Minor and/or Major Defect	Garage/Car Port
Comments	
Ceiling plaster is separated from ceiling joists and falling. Builder to attend and rectify the issue.

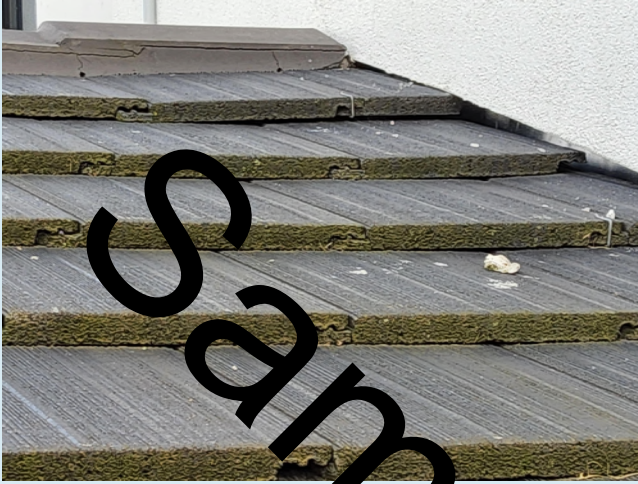
Tiles above garage had not been laid flat and properly. There are some uplifted tiles which allow rain and moisture enter the roof space. Builder to attend and rectify

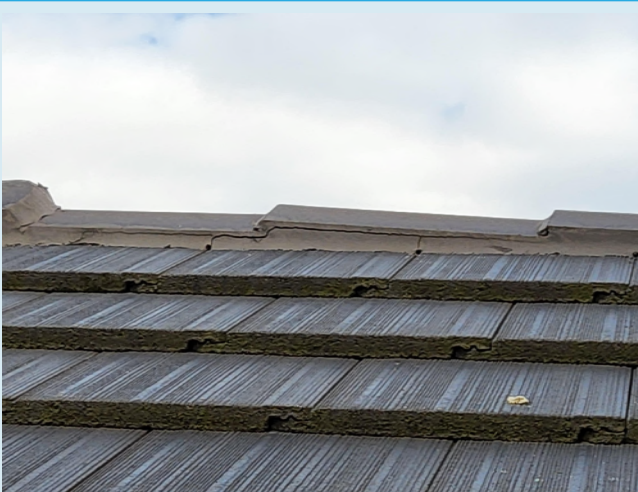
Pointing needs to be fixed. Currently many cracks are visible. Builder to attend and rectify
